**Flood Control Project Maintenance
Levee Inspections**
LMA District Cover Sheet
Spring 2019 Levee Inspection Results

Reclamation District No. 0349 Sutter Island

Spring 2019 Levee Inspection Results

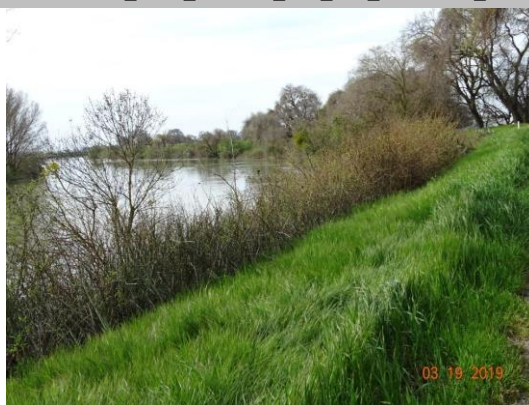
Photo 1 of 1 : SP_2019_RD0349_205_104_20190320_00117.jpg

LM Start	3.64	Rating **	U	Issue No.	104
LM End	3.67	Issue Type +	Ma	Location *	WS
Category	Earthen Levee			GPS Latitude/Longitude	
				Start	End
Item	Vegetation			38.262068 °	38.261835 °
				-121.594283 °	-121.594553 °
DWR ID	DWR_RD0349_02_s_2019_104				
Comment Code					
V2 : Remove the wild growth other than native grasses from the levee slopes.					
Inspector Comment					
Wild growth is blocking the view down the waterside slope.

View looking downstream at wild growth on the waterside slope (Spring 2019).

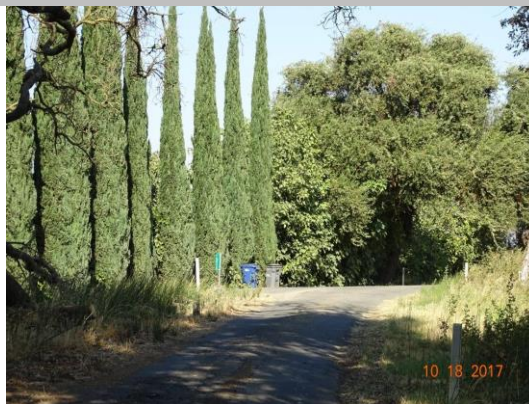
Photo 1 of 1 : SP_2019_RD0349_205_65_20190311_00043.jpg

LM Start	3.66	Rating **	M	Issue No.	65
LM End	3.66	Issue Type +	En	Location *	LS
Category	Earthen Levee			GPS Latitude/Longitude	
				Start	End
Item	Vegetation			38.261933 °	38.261933 °
				-121.594549 °	-121.594549 °
DWR ID	DWR_RD0349_02_f_2017_65				
Comment Code					
V6 : Landscaping					
Inspector Comment					
Trim/thin fig trees and evergreen shrubs to allow visibility and access to levee slope.

View of fig trees and evergreen shrubs on the landside levee slope

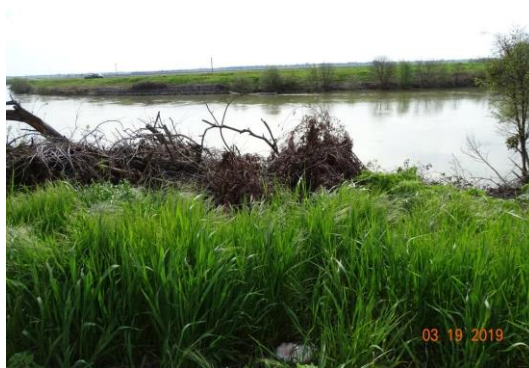
Photo 1 of 1 : SP_2019_RD0349_205_47_20190320_00118.jpg

LM Start	3.67	Rating **	U	Issue No.	47
LM End	3.67	Issue Type +	En	Location *	WS
Category	Earthen Levee			GPS Latitude/Longitude	
				Start	End
Item	Encroachments			38.261815 °	38.261815 °
				-121.594600 °	-121.594600 °
DWR ID	DWR_RD0349_02_f_2018_47				
Comment Code					
PR : Prunings					
Inspector Comment					
Remove prunings from the waterside shoulder.

View of prunings on the waterside shoulder (Spring 2019).

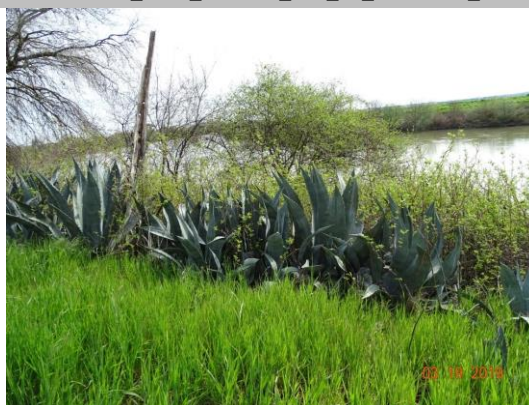
Photo 1 of 1 : SP_2019_RD0349_205_64_20190320_00119.jpg

LM Start	3.72	Rating **	U	Issue No.	64
LM End	3.72	Issue Type +	En	Location *	WS
Category	Earthen Levee			GPS Latitude/Longitude	
				Start	End
Item	Vegetation			38.261143 °	38.261143 °
				-121.595071 °	-121.595071 °
DWR ID	DWR_RD0349_02_s_2018_64				
Comment Code					
V6 : Landscaping					
Inspector Comment					
Remove cactus (century plants) from the waterside shoulder.

View of cactus on the waterside shoulder (Spring 2019).

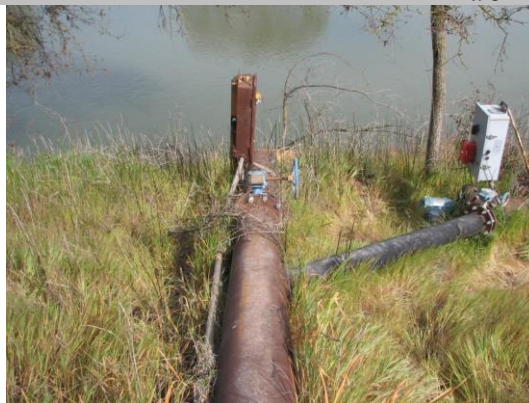
Photo 2 of 3 : UCIP_SP_2019_21612_36682.jpg

Comment Code						
Inspector Comment						
FS_ID:21612 DS_ID:24162 EP_NO: 8188 Repair Type: Non-Urgent Crossing Status: Found UCIP Comments: Dense vegetation limits the inspector's visibility to identify signs of pipe failure (leaks) along the landward slope. Recommend removing vegetation along pipe alignment to conduct proper inspection of structure and appurtenances. Unable to determine if crossing is in use. Note date on photos should be 3/18/09 not 7/26/08 camera metadata is incorrect. FIELD_STRUCT_DESC: 12-inch steel irrigation pipe and 1.25-inch electrical conduit through the levee, 5.0 feet below the levee crown. Steel cutoff wall around pipe at center of levee. Siphon breaker on shoulder. Pump and pump house on the waterside (WS). Service pole, discharge box and concrete standpipe at landside (LS) toe. (12-inch pipe authorized under Permit No. 8188, 1973 - E. Salman, 10-inch pipe removed) [Additional Reference(s): DWR Levee Log, 2005] FS Date: 3/18/2009

View of crossing on waterward side.

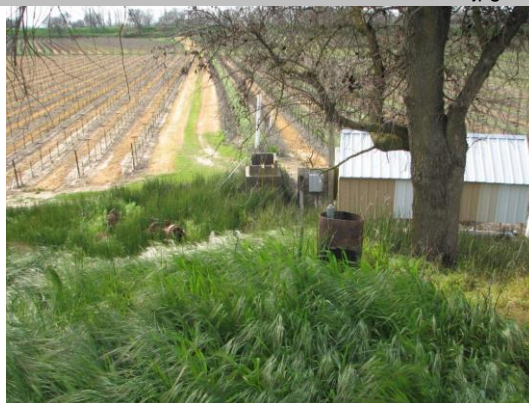
Photo 3 of 3 : UCIP_SP_2019_21612_36683.jpg

Overview of landward side--appurtenances include distribution box, stand pipe, pump house, and control panel.

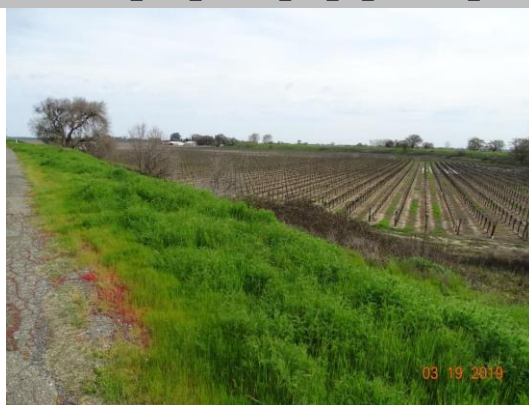
Photo 1 of 1 : SP_2019_RD0349_206_32_20190320_00084.jpg

LM Start	0.01	Rating **	M	Issue No.	32
LM End	6.44	Issue Type +	Ma	Location *	LS
Category	Earthen Levee			GPS Latitude/Longitude	
				Start	End
Item	Vegetation			38.254933 °	38.327597 °
				-121.600118 °	-121.577780 °
DWR ID	DWR_RD0349_03_s_2019_32				
Comment Code					
V1 : Control annual grass and weeds on the levee slopes and easements.					
Inspector Comment					
Maintain annual vegetation on the landside slope.

View looking upstream at annual vegetation on the landside slope (Spring 2019).

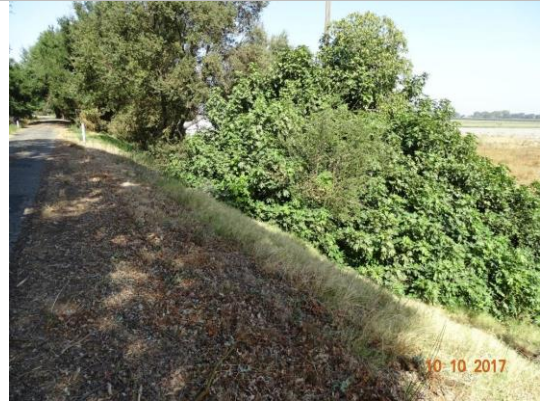
Photo 1 of 1 : SP_2019_RD0349_206_8_20190311_00001.jpg

LM Start	0.76	Rating **	M	Issue No.	8
LM End	0.76	Issue Type +	Ma	Location *	LS
Category	Earthen Levee			GPS Latitude/Longitude	
				Start	End
Item	Trim / Thin Trees			38.265637 °	38.265637 °
				-121.601640 °	-121.601640 °
DWR ID	DWR_RD0349_03_f_2017_8				
Comment Code					
T2 : Thin trees to allow visibility of the ground and room to flood fight.					
Inspector Comment					
Trim large fig tree to allow visibility and access to landside levee slope.

View of trees on landside slope

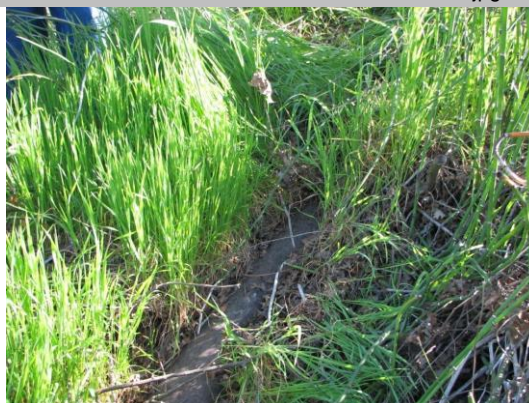
Photo 3 of 3 : UCIP_SP_2019_43442_36704.jpg

Pipe covered by dense vegetation.

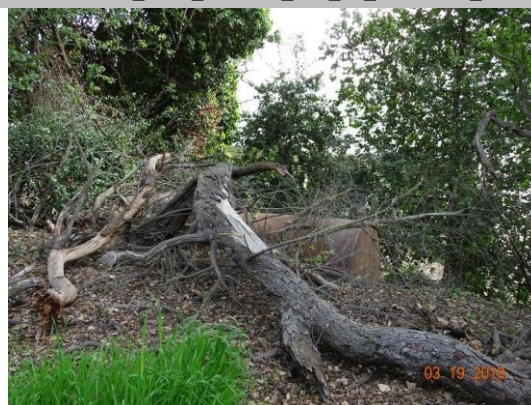
Photo 1 of 1 : SP_2019_RD0349_206_44_20190320_00086.jpg

LM Start	0.80	Rating **	M	Issue No.	44
LM End	0.80	Issue Type +	En	Location *	LS
Category	Earthen Levee			GPS Latitude/Longitude	
				Start	End
Item	Encroachments			38.266168 °	38.266168 °
				-121.601834 °	-121.601834 °
DWR ID	DWR_RD0349_03_s_2018_44				
Comment Code					
TA : Tank					
Inspector Comment					
A 300 gallon metal tank is located on shoulder.

View of tank on the land side shoulder (Spring 2019).

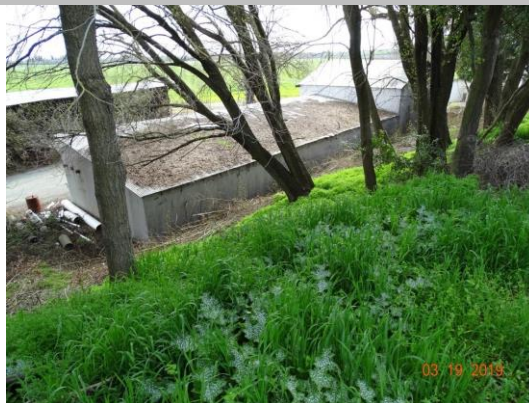
Photo 1 of 1 : SP_2019_RD0349_206_46_20190320_00087.jpg

LM Start	0.84	Rating **	U	Issue No.	46
LM End	0.84	Issue Type +	En	Location *	LS
Category	Earthen Levee			GPS Latitude/Longitude	
				Start	End
Item	Encroachments			38.266703 °	38.266703 °
				-121.602047 °	-121.602047 °
DWR ID	DWR_RD0349_03_s_2019_46				
Comment Code					
BU : Building					
Inspector Comment					
A building is located within 10 feet of the landside toe.

View of building on the landside toe (Spring 2019).

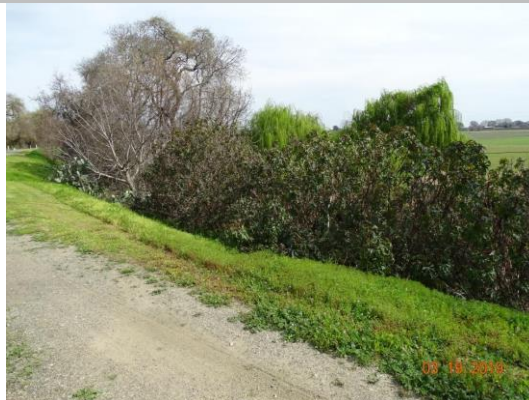
Photo 1 of 1 : SP_2019_RD0349_206_49_20190320_00089.jpg

LM Start	1.09	Rating **	U	Issue No.	49
LM End	1.09	Issue Type +	En	Location *	LS
Category	Earthen Levee			GPS Latitude/Longitude	
				Start	End
Item	Vegetation			38.270158 °	38.270158 °
				-121.603579 °	-121.603579 °
DWR ID	DWR_RD0349_03_s_2019_49				
Comment Code					
V6 : Landscaping					
Inspector Comment					
Remove cactus from landside slope.

View of cactus on the landside slope (Spring 2019).

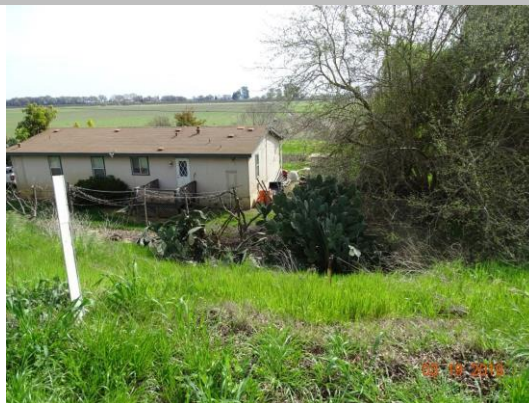
Photo 1 of 1 : SP_2019_RD0349_206_113_20190320_00090.jpg

LM Start	1.23	Rating **	M	Issue No.	113
LM End	1.23	Issue Type +	En	Location *	LS
Category	Earthen Levee			GPS Latitude/Longitude	
				Start	End
Item	Vegetation			38.272148 °	38.272148 °
				-121.603245 °	-121.603245 °
DWR ID	DWR_RD0349_03_f_2018_113				
Comment Code					
V6 : Landscaping					
Inspector Comment					
Remove cactus from the landside slope.

View of cactus on the landside slope (Spring 2019).

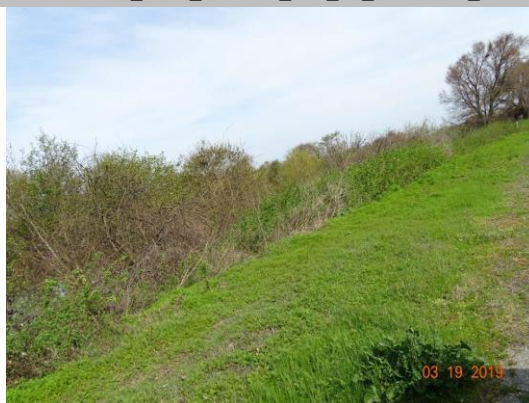
Photo 1 of 1 : SP_2019_RD0349_206_48_20190320_00091.jpg

LM Start	1.54	Rating **	U	Issue No.	48
LM End	1.60	Issue Type +	Ma	Location *	WS
Category	Earthen Levee			GPS Latitude/Longitude	
				Start	End
Item	Vegetation			38.276217 °	38.277103 °
				-121.600940 °	-121.600643 °
DWR ID	DWR_RD0349_03_s_2019_48				
Comment Code					
V2 : Remove the wild growth other than native grasses from the levee slopes.					
Inspector Comment					
Maintain vegetation within 20 feet of the waterside shoulder.

View looking upstream at thick wild growth within 20 feet of the waterside shoulder (Spring 2019).

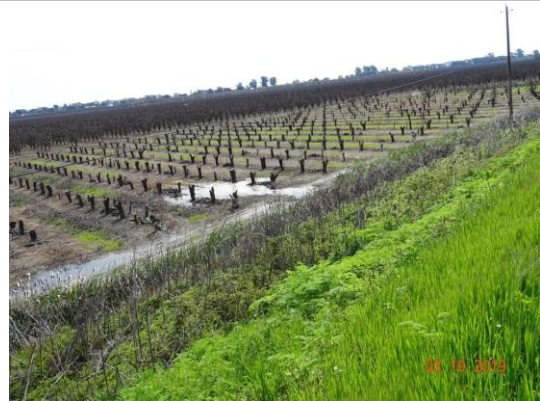
Photo 1 of 1 : SP_2019_RD0349_206_56_20190320_00092.jpg

LM Start	2.85	Rating **	M	Issue No.	56
LM End	2.85	Issue Type +	En	Location *	LS
Category	Earthen Levee			GPS Latitude/Longitude	
				Start	End
Item	Encroachments			38.293753 °	38.293753 °
				-121.604125 °	-121.604125 °
DWR ID	DWR_RD0349_03_s_2019_56				
Comment Code					
DT : Ditch					
Inspector Comment					
Ditch at landside toe outlined by cattails.

View looking downstream at ditch on the landside toe (Spring 2019).

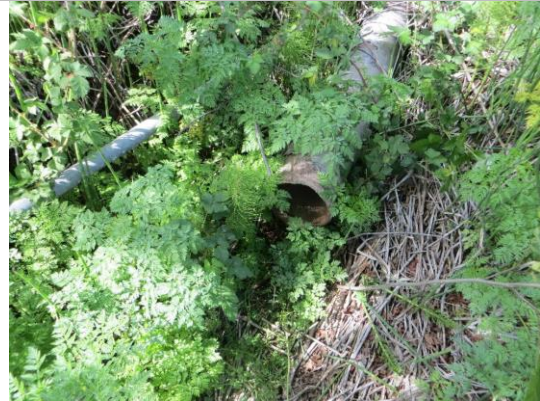
Photo 2 of 3 : UCIP_SP_2019_53345_73742.jpg

1.5-inch filler pipe and 8-inch steel irrigation pipe at LS toe.

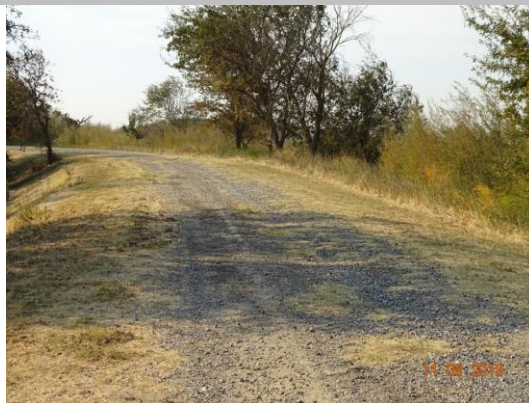
Photo 1 of 1 : SP_2019_RD0349_206_100_20190311_00015.jpg

LM Start	2.97	Rating **	M	Issue No.	100
LM End	2.97	Issue Type +	Ma	Location *	WS
Category	Earthen Levee			GPS Latitude/Longitude	
				Start	End
Item	Vegetation			38.295445 °	38.295445 °
				-121.604692 °	-121.604692 °
DWR ID	DWR_RD0349_03_f_2018_100				
Comment Code					
V1 : Control annual grass and weeds on the levee slopes and easements.					
Inspector Comment

View looking downstream at vegetation off the waterside shoulder (November 2018).

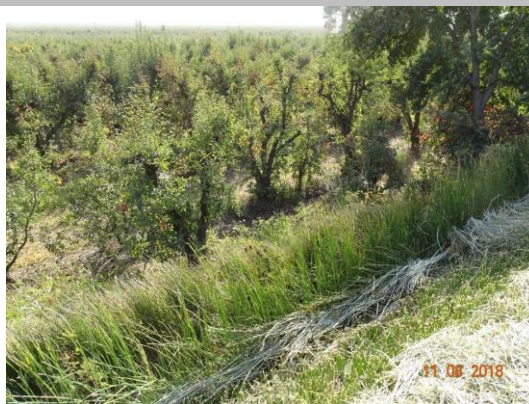
Photo 1 of 1 : SP_2019_RD0349_206_105_20190311_00018.jpg

LM Start	3.04	Rating **	M	Issue No.	105
LM End	3.15	Issue Type +	En	Location *	LS
Category	Earthen Levee			GPS Latitude/Longitude	
				Start	End
Item	Encroachments			38.296388 °	38.297773 °
				-121.604558 °	-121.603635 °
DWR ID	DWR_RD0349_03_f_2018_105				
Comment Code					
CR : Crops					
Inspector Comment					
Orchard trees are located at landside toe.

View looking slightly downstream at orchard trees on the landside toe (November 2018).

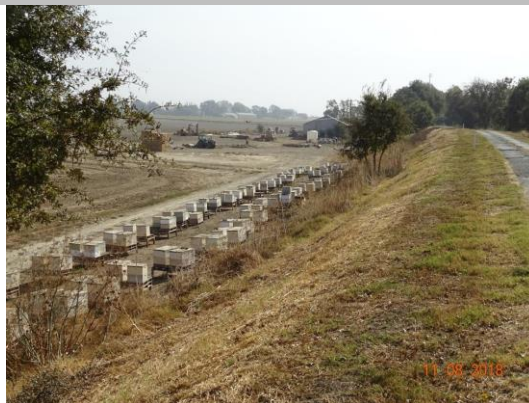
Photo 1 of 1 : SP_2019_RD0349_206_106_20190311_00019.jpg

LM Start	3.15	Rating **	M	Issue No.	106
LM End	3.15	Issue Type +	Ma	Location *	LS
Category	Earthen Levee			GPS Latitude/Longitude	
				Start	End
Item	Vegetation			38.297773 °	38.297773 °
				-121.603635 °	-121.603635 °
DWR ID	DWR_RD0349_03_f_2018_106				
Comment Code					
V1 : Control annual grass and weeds on the levee slopes and easements.					
Inspector Comment					
Remove vegetation all the way down the landside slope.

View of vegetation on slope

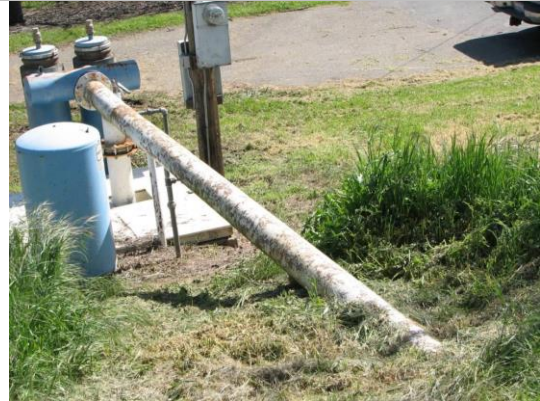
Photo 3 of 3 : UCIP_SP_2019_44389_36874.jpg

LM Start	3.34	Rating **	M	Issue No.	129 (cont)	
LM End	3.34	Issue Type +	En	Location *		
Category	Supplemental			GPS Latitude/Longitude		
				Start	End	
Item	DWR UCIP Field Study			38.299703 °	38.299703 °	
				-121.601112 °	-121.601112 °	
DWR ID	24179					
Comment Code						
Inspector Comment						
FS_ID:44389 DS_ID:24179 EP_NO: N/A Repair Type: Non-Urgent Crossing Status: Found UCIP Comments: Crossing altered--need to contact owner to obtain permit number authorizing work. Dense vegetation limits the inspector's visibility to identify signs of pipe failure (leaks) along the slope. Recommend removing vegetation along pipe alignment to conduct proper inspection of structure and appurtenances. Note date on photos should be 3/18/09 not 7/26/08 camera metadata is incorrect. FIELD_STRUCT_DESC: *DELETE* FS Date: 4/9/2015

View of landward side.

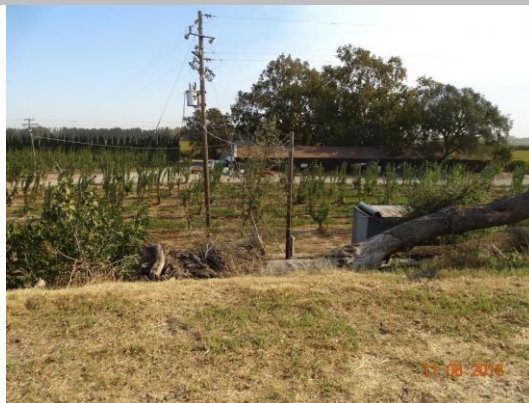
Photo 1 of 1 : SP_2019_RD0349_206_75_20190311_00011.jpg

LM Start	3.96	Rating **	M	Issue No.	75
LM End	3.96	Issue Type +	En	Location *	LS
Category	Earthen Levee			GPS Latitude/Longitude	
				Start	End
Item	Encroachments			38.307532 °	38.307532 °
				-121.596888 °	-121.596888 °
DWR ID	DWR_RD0349_03_s_2018_75				
Comment Code					
TR : Tree or limb					
Inspector Comment					
Remove fallen tree on landside slope.

View of fallen tree on the landside slope (November 2018).

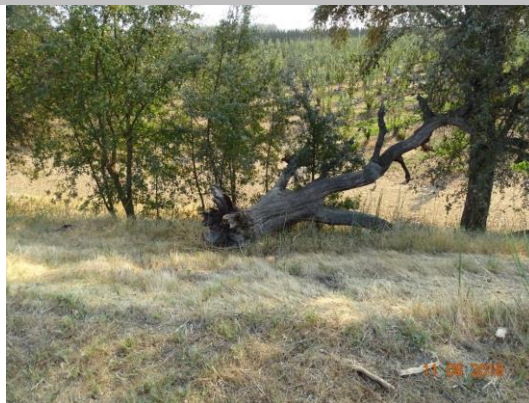
Photo 1 of 1 : SP_2019_RD0349_206_102_20190311_00016.jpg

LM Start	4.19	Rating **	M	Issue No.	102
LM End	4.19	Issue Type +	Ma	Location *	LS
Category	Earthen Levee			GPS Latitude/Longitude	
				Start	End
Item	Encroachments			38.310490 °	38.310490 °
				-121.597265 °	-121.597265 °
DWR ID	DWR_RD0349_03_f_2018_102				
Comment Code					
TR : Tree or limb					
Inspector Comment					
Remove tree from the landside slope.

View of tree on the landside slope (November 2018).

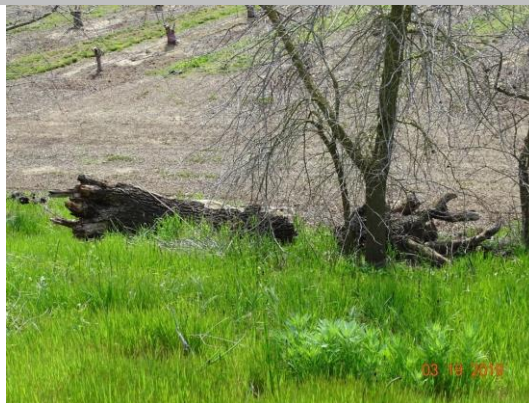
Photo 1 of 1 : SP_2019_RD0349_206_58_20190320_00093.jpg

LM Start	4.22	Rating **	U	Issue No.	58
LM End	4.22	Issue Type +	En	Location *	LS
Category	Earthen Levee			GPS Latitude/Longitude	
				Start	End
Item	Encroachments			38.310675 °	38.310675 °
				-121.596845 °	-121.596845 °
DWR ID	DWR_RD0349_03_s_2019_58				
Comment Code					
TR : Tree or limb					
Inspector Comment					
Remove downed tree trunks from landside slope.

View looking downstream at downed tree trunk on the landside slope (Spring 2019).

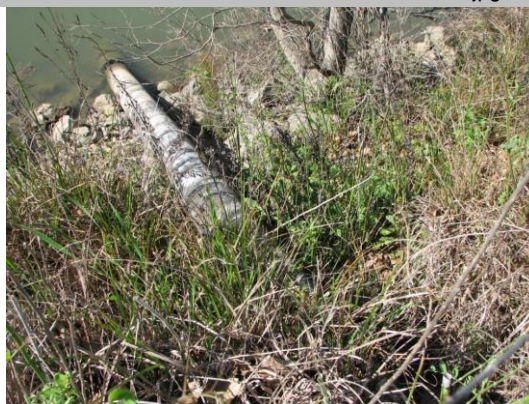
Photo 2 of 3 : UCIP_SP_2019_43431_36801.jpg

Pipe located on waterward side.

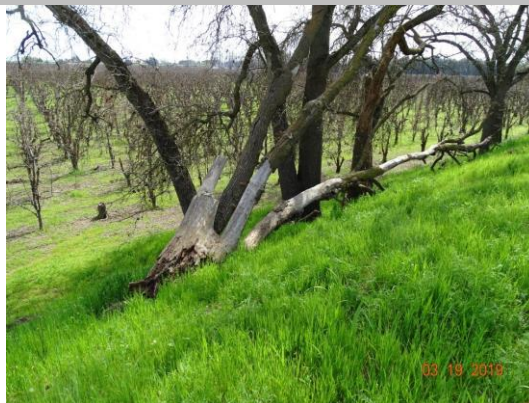
Photo 1 of 1 : SP_2019_RD0349_206_61_20190320_00094.jpg

LM Start	5.10	Rating **	U	Issue No.	61
LM End	5.10	Issue Type +	En	Location *	LS
Category	Earthen Levee			GPS Latitude/Longitude	
				Start	End
Item	Encroachments			38.321130 °	38.321130 °
				-121.589678 °	-121.589678 °
DWR ID	DWR_RD0349_03_s_2019_61				
Comment Code					
TR : Tree or limb					
Inspector Comment					
Remove fallen tree from the landside slope.

View looking downstream at down tree on the landside slope (Spring 2019).

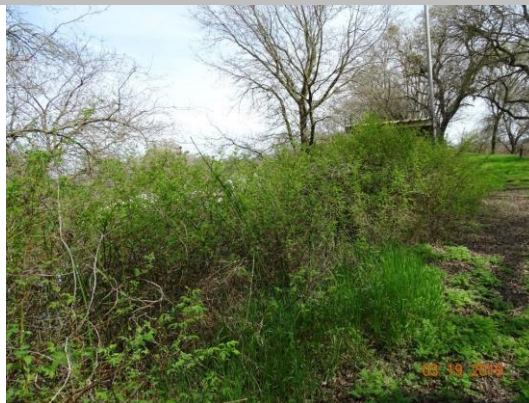
Photo 1 of 1 : SP_2019_RD0349_206_42_20190320_00095.jpg

LM Start	5.37	Rating **	U	Issue No.	42
LM End	5.37	Issue Type +	En	Location *	WS
Category	Earthen Levee			GPS Latitude/Longitude	
				Start	End
Item	Vegetation			38.323446 °	38.323446 °
				-121.586792 °	-121.586792 °
DWR ID	DWR_RD0349_03_f_2017_42				
Comment Code					
V6 : Landscaping					
Inspector Comment					
Berry bushes should be removed from waterside shoulder.

View looking upstream at berry bushes on the waterside shoulder (Spring 2019).

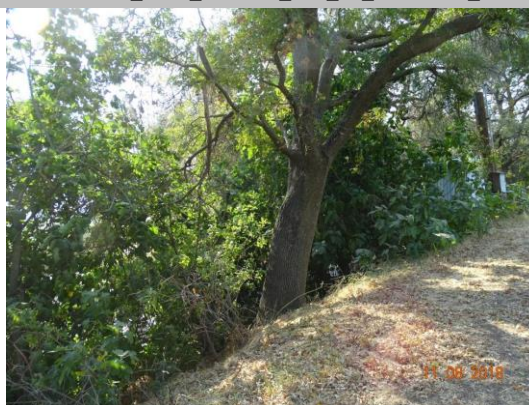
Photo 1 of 1 : SP_2019_RD0349_206_97_20190311_00014.jpg

LM Start	5.38	Rating **	U	Issue No.	97
LM End	5.38	Issue Type +	En	Location *	LS
Category	Earthen Levee			GPS Latitude/Longitude	
				Start	End
Item	Vegetation			38.323583 °	38.323583 °
				-121.586527 °	-121.586527 °
DWR ID	DWR_RD0349_03_f_2018_97				
Comment Code					
V6 : Landscaping					
Inspector Comment					
Thin fig trees on the landside slope.

View of fig trees on the landside slope (November 2018).

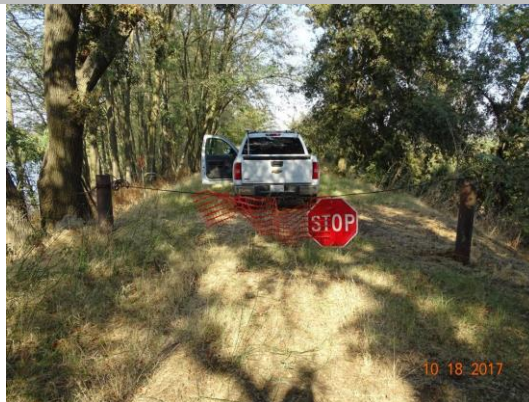
Photo 1 of 1 : SP_2019_RD0349_206_21_20190311_00002.jpg

LM Start	5.39	Rating **	U	Issue No.	21
LM End	5.39	Issue Type +	En	Location *	CR
Category	Earthen Levee			GPS Latitude/Longitude	
				Start	End
Item	Encroachments			38.323659 °	38.323659 °
				-121.586421 °	-121.586421 °
DWR ID	DWR_RD0349_03_f_2017_21				
Comment Code					
FE : Fence					
Inspector Comment					
Cable gates are banned. Must remove. No lock on this gate.

Cable gates are banned. Must remove. No lock on this gate.

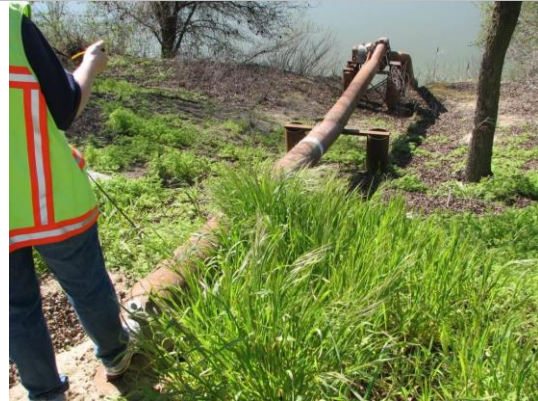
Photo 3 of 3 : UCIP_SP_2019_50016_36842.jpg

Comment Code						
Inspector Comment						
FS_ID:50016 DS_ID:24190 EP_NO: 16077 Repair Type: Non-Urgent Crossing Status: Found UCIP Comments: 8/22/2016 Crossing has been downgraded from Urgent to Non-Urgent no signs of pipe failure were present on levee crown or slopes during site visit. Need to contact owner to determine last internal inspection completed. (DWR UCIP - omagana)3/19/2009 Soil disturbed on landward slope--need to contact owner. Also vegetation limits the inspector's visibility to identify signs of pipe failure (leaks) along the slope. Recommend removing vegetation along pipe alignment to conduct proper inspection of structure and appurtenances. Note date on photos should be 3/18/09 not 7/26/08 camera metadata is incorrect. (DWR UCIP - omagana) FIELD_STRUCT_DESC: 10-inch irrigation pipe of unknown material through the levee, 3.8 feet below the crown. Pump in pump house on waterside (WS). Service pole on WS slope. Concrete standpipe and distribution box located on the WS toe. Pipe is exposed on both slopes. Section of pipe under crown, between shoulders, removed and replaced with 10-inch steel pipe in November 20, 1991, no permit application was filed. In August 13, 1993, Mr. Steve Makis of Flood Management, revealed that the pipe was not soil proofed, and siphon breaker was not installed, and backfill was less than 90 % and less than 2-foot of cover through the levee crown. Pipe was required to be completely removed and replaced in September 15, 1993. (10-inch authorized under Permit No. 16077, 1993 - John McCormack Company, 10-inch pipe replaces the USACE O&M 10-inch pipe referenced as HLM 5.9) [Additional Reference(s): DWR Levee Log, 2005. USACE San Joaquin O&M Manual Unit No. 110, May 1959, HLM 5.9, Drawing not available]. FS Date: 8/17/2016

View of WS.

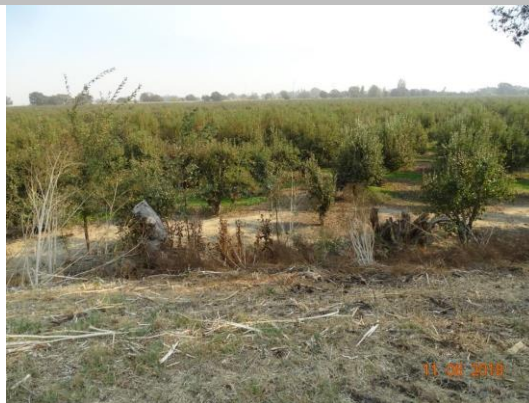
Photo 1 of 1 : SP_2019_RD0349_206_95_20190311_00013.jpg

LM Start	5.71	Rating **	M	Issue No.	95	
LM End	5.71	Issue Type +	Ma	Location *	LS	
Category	Earthen Levee			GPS Latitude/Longitude		
				Start		End
Item	Encroachments			38.327828 °		38.327828 °
				-121.584960 °		-121.584960 °
DWR ID	DWR_RD0349_03_f_2018_95					
Comment Code						
TR : Tree or limb						
Inspector Comment						
Remove down trees from the landside slope.

View of down trees on the landside slope (November 2018).

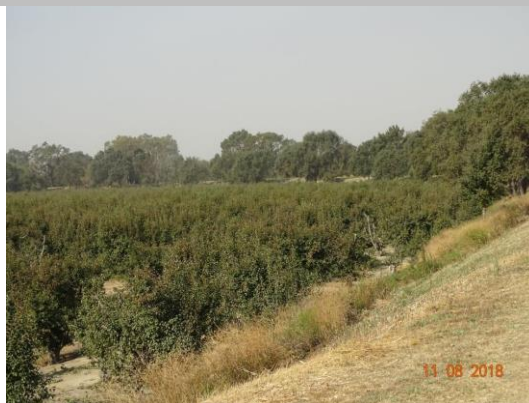
Photo 1 of 1 : SP_2019_RD0349_206_92_20190311_00012.jpg

LM Start	5.88	Rating **	M	Issue No.	92
LM End	5.88	Issue Type +	Ma	Location *	LS
Category	Earthen Levee			GPS Latitude/Longitude	
				Start	End
Item	Vegetation			38.330110 °	38.330110 °
				-121.584628 °	-121.584628 °
DWR ID	DWR_RD0349_03_f_2018_92				
Comment Code					
V1 : Control annual grass and weeds on the levee slopes and easements.					
Inspector Comment					
Remove vegetation all the way down to the landside toe.

View looking upstream at vegetation partway down the landside slope (November 2018).

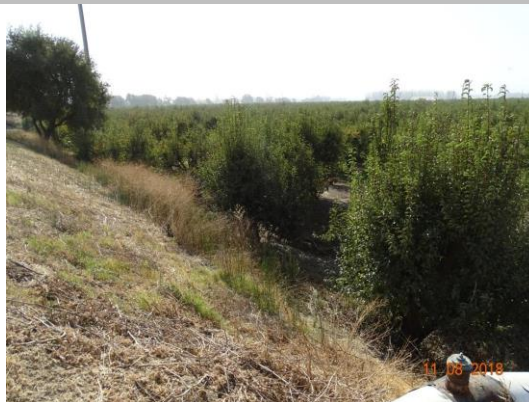
Photo 1 of 1 : SP_2019_RD0349_206_74_20190311_00010.jpg

LM Start	5.93	Rating **	M	Issue No.	74
LM End	6.32	Issue Type +	En	Location *	LS
Category	Earthen Levee			GPS Latitude/Longitude	
				Start	End
Item	Encroachments			38.330800 °	38.328882 °
				-121.584355 °	-121.579105 °
DWR ID	DWR_RD0349_03_f_2018_74				
Comment Code					
CR : Crops					
Inspector Comment					
Orchard trees are encroaching on the landside toe.

View looking slightly upstream at orchard trees on the landside toe (November 2018).

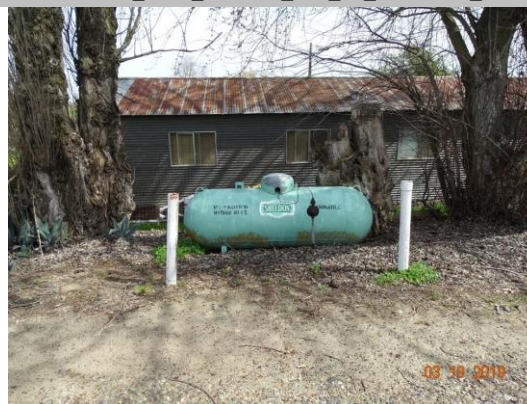
Photo 1 of 1 : SP_2019_RD0349_206_76_20190320_00096.jpg

LM Start	6.42	Rating **	M	Issue No.	76
LM End	6.42	Issue Type +	En	Location *	WS
Category	Earthen Levee			GPS Latitude/Longitude	
				Start	End
Item	Encroachments			38.327757 °	38.327757 °
				-121.578000 °	-121.578000 °
DWR ID	DWR_RD0349_03_s_2019_76				
Comment Code					
TA : Tank					
Inspector Comment					
A tank is located on the waterside shoulder.

View of tank on the waterside shoulder (Spring 2019).

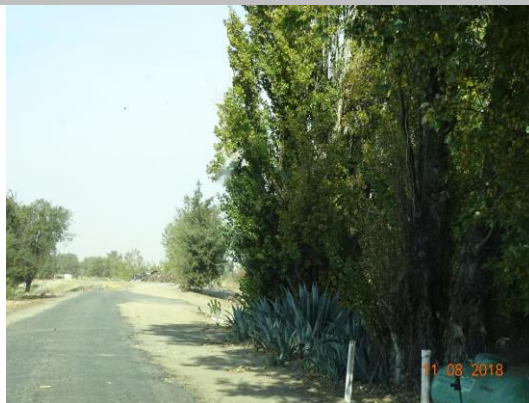
Photo 1 of 1 : SP_2019_RD0349_206_66_20190311_00008.jpg

LM Start	6.42	Rating **	U	Issue No.	66
LM End	6.42	Issue Type +	En	Location *	WS
Category	Earthen Levee			GPS Latitude/Longitude	
				Start	End
Item	Vegetation			38.327750 °	38.327750 °
				-121.577968 °	-121.577968 °
DWR ID	DWR_RD0349_03_f_2018_66				
Comment Code					
V6 : Landscaping					
Inspector Comment

View looking downstream at landscaping on the waterside shoulder (November 2018).

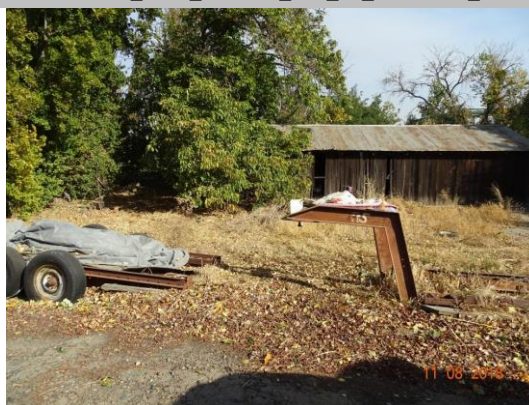
Photo 1 of 1 : SP_2019_RD0349_206_65_20190311_00007.jpg

LM Start	6.47	Rating **	M	Issue No.	65
LM End	6.47	Issue Type +	En	Location *	WS
Category	Earthen Levee			GPS Latitude/Longitude	
				Start	End
Item	Encroachments			38.327287 °	38.327287 °
				-121.577333 °	-121.577333 °
DWR ID	DWR_RD0349_03_f_2018_65				
Comment Code					
EQ : Equipment					
Inspector Comment					
Remove equipment from the waterside slope.

View of trailer and other equipment on the waterside shoulder (November 2018).
